Mission Technology Forum

LAC Performance Validation

. . . Dennis Reuter

Code 693, NASA Goddard Space Flight Center

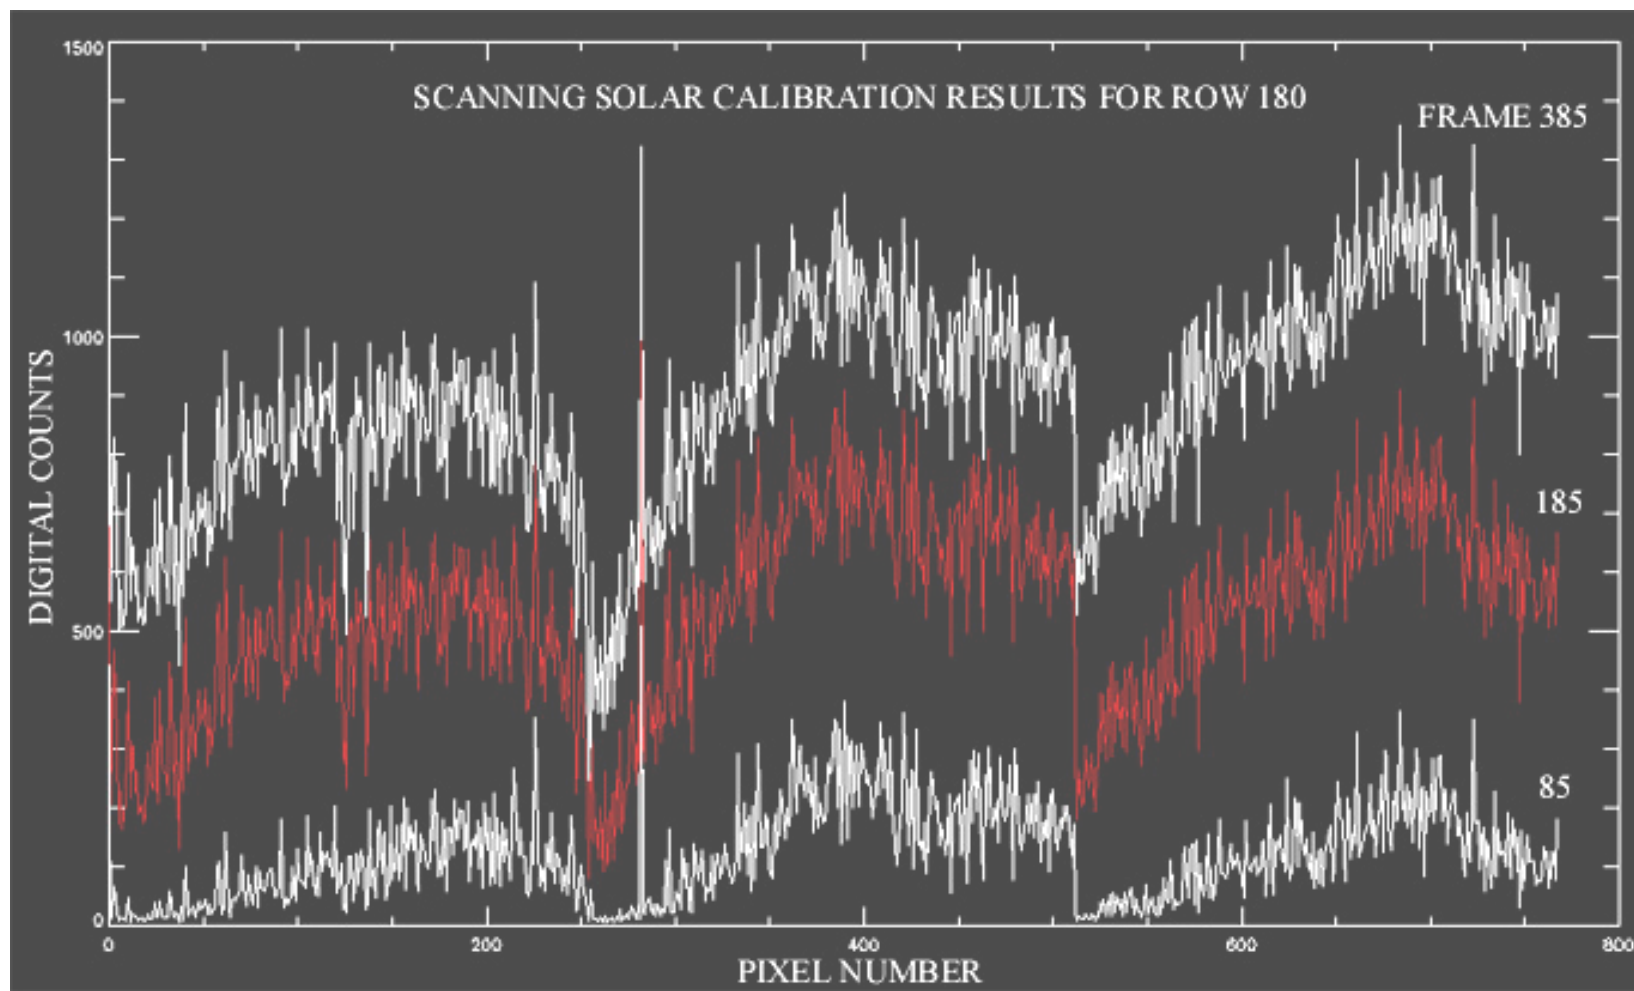
“Fixed Pattern” Signal

- ◆ *Large nearly additive “fixed pattern” contribution to signal*
- ◆ *Became apparent after launch*
- ◆ *Constant in position*
- ◆ *Constant in time*
- ◆ *Reduces low illumination accuracy for some pixels*
- ◆ *Requires measurements unaffected by atmospheric absorption*
- ◆ *Corrected using scanning solar calibration*

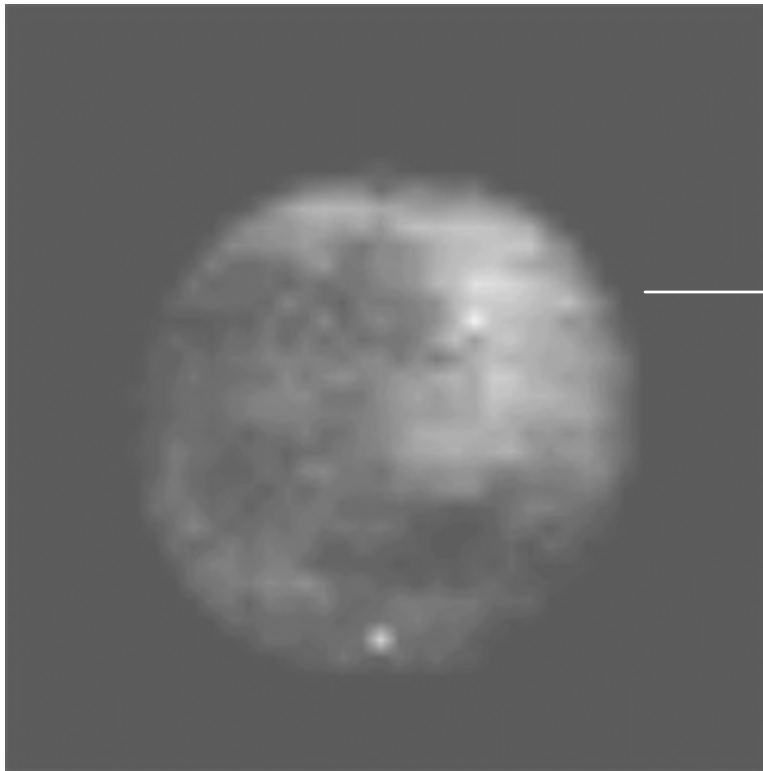
Image Quality (Edge Sharpness)

Lunar Image Expanded by a Factor of 8

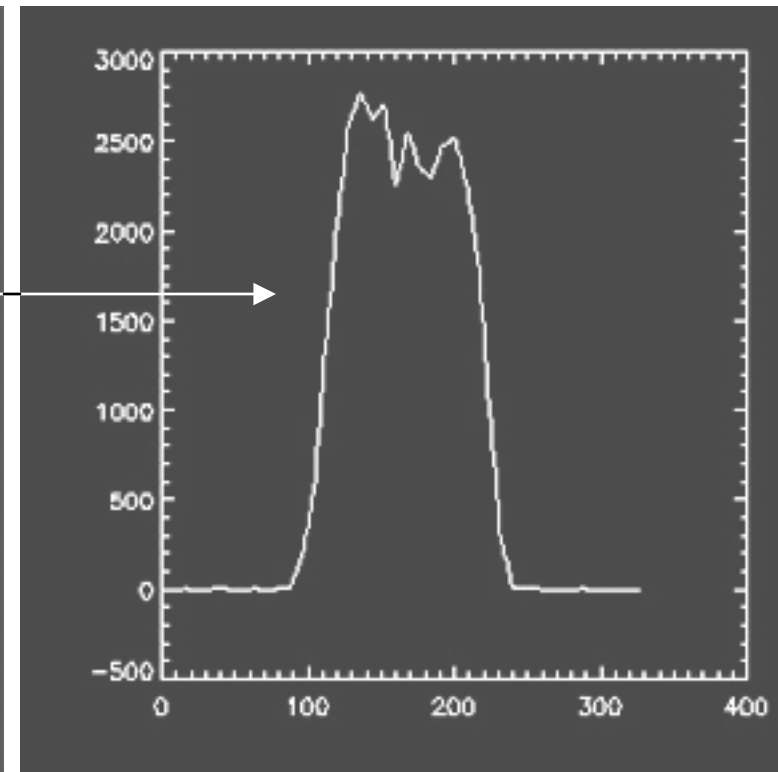
Horizontal Slice Through Expanded Lunar Image
Rise and Fall About 1 Pixel in Normal Image.

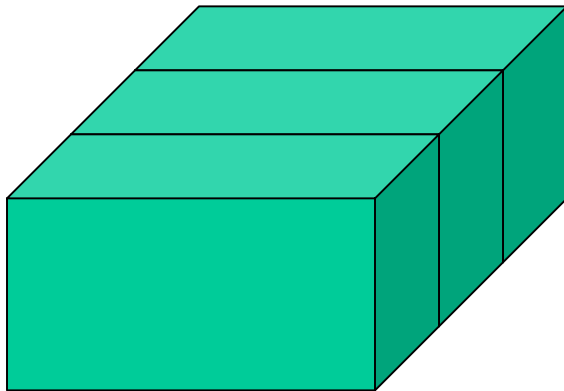
Level-1R

◆ *Band Sequential (BSQ)*

- *instrument clock, header data*
- *pixel pointing map, filter frequency map*
- *spacecraft meta data (YYYY_DDD_lac/gps/acs.hdf)*

$$I_{i,j,t} \Rightarrow I_{x,y,v}$$

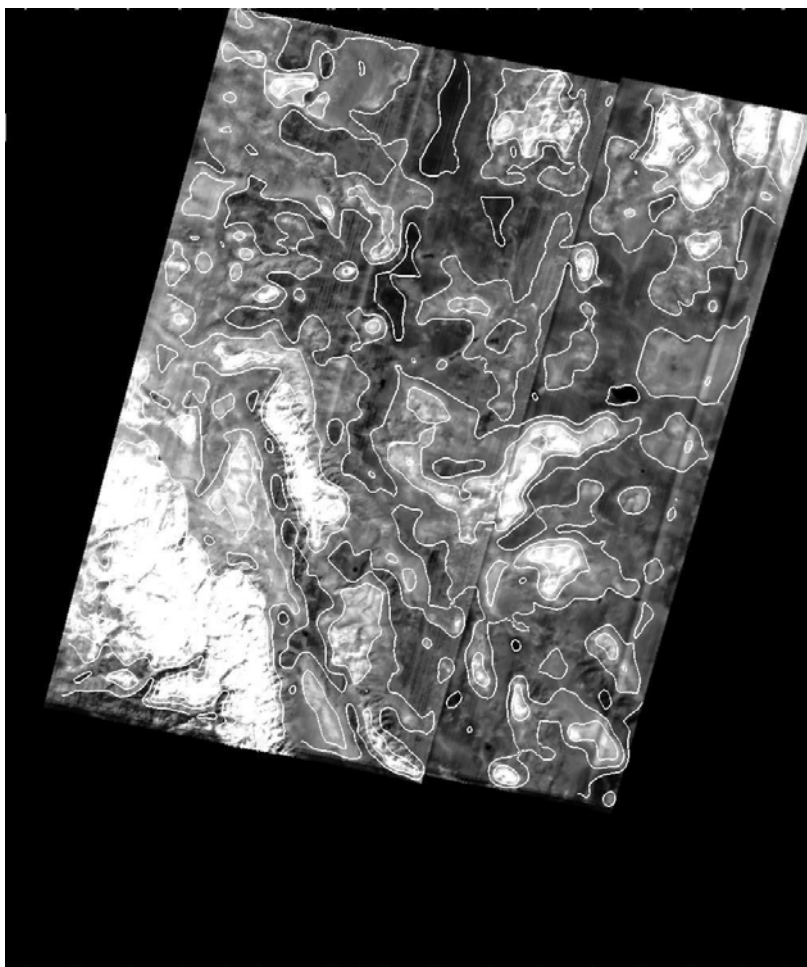
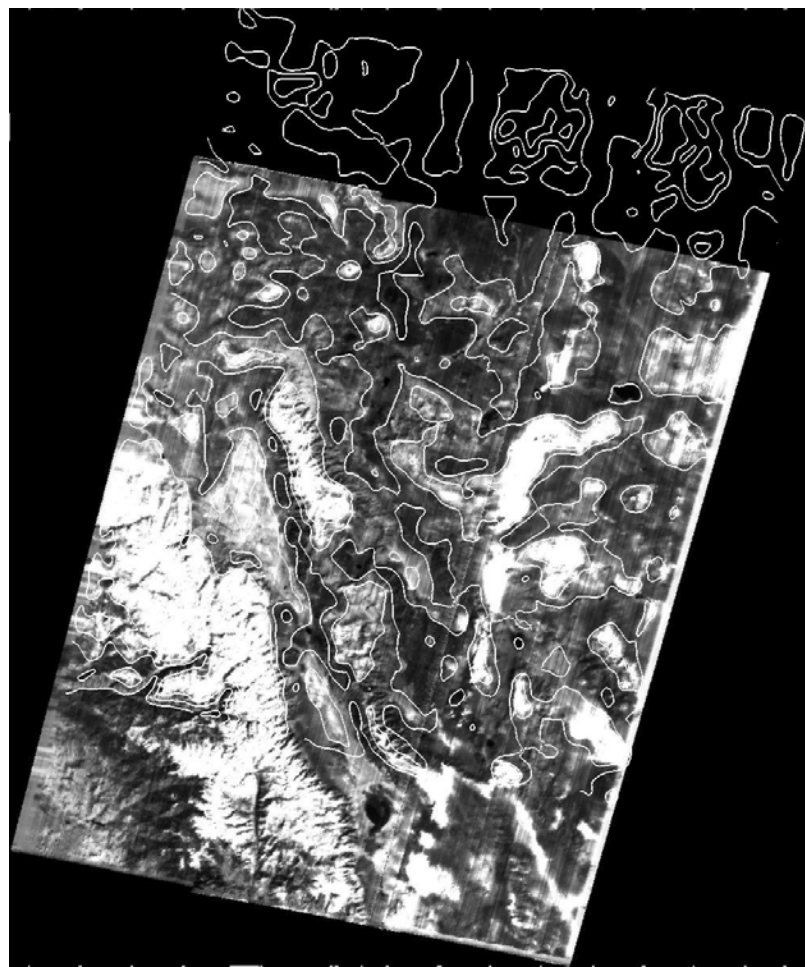
Band Alignment

Scan of Cuprite, NV 1200 frames

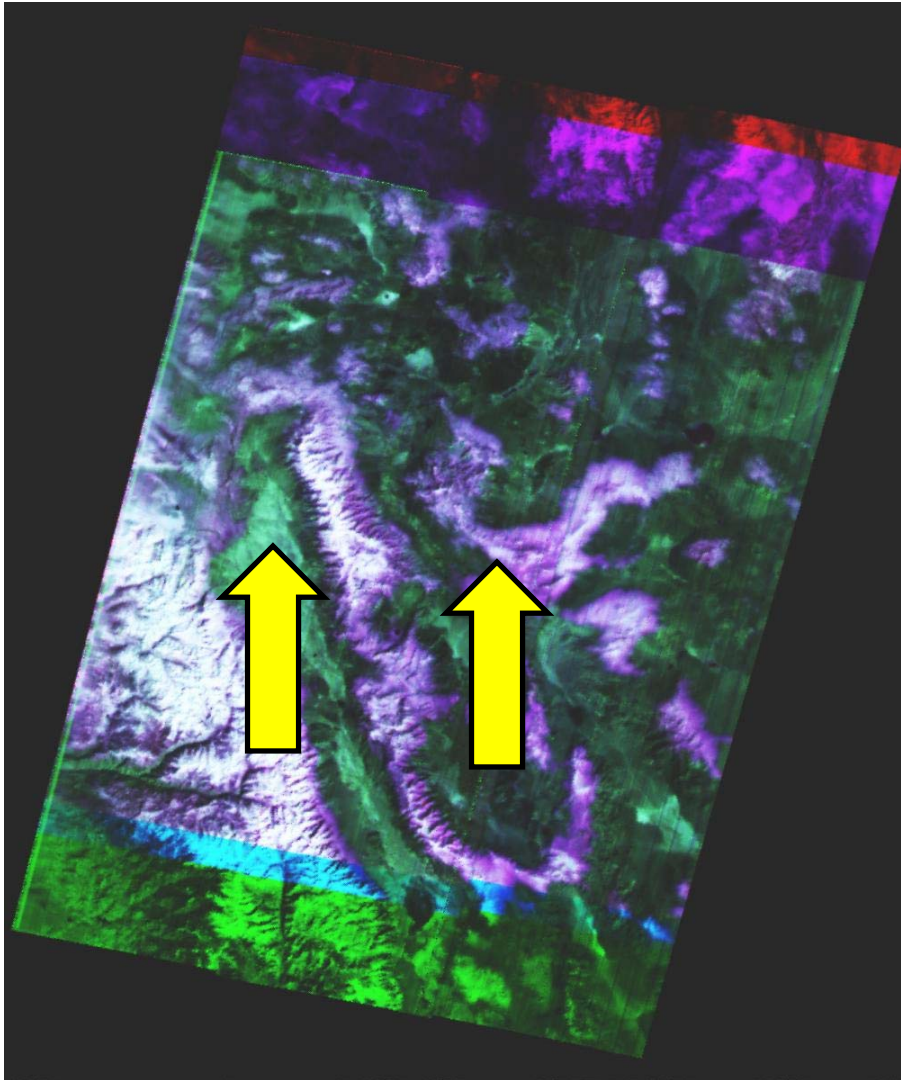
Color Composite Images

Cuprite, NV March 1, 2001
red=1.32, green=1.03, blue=0.98 (μm)

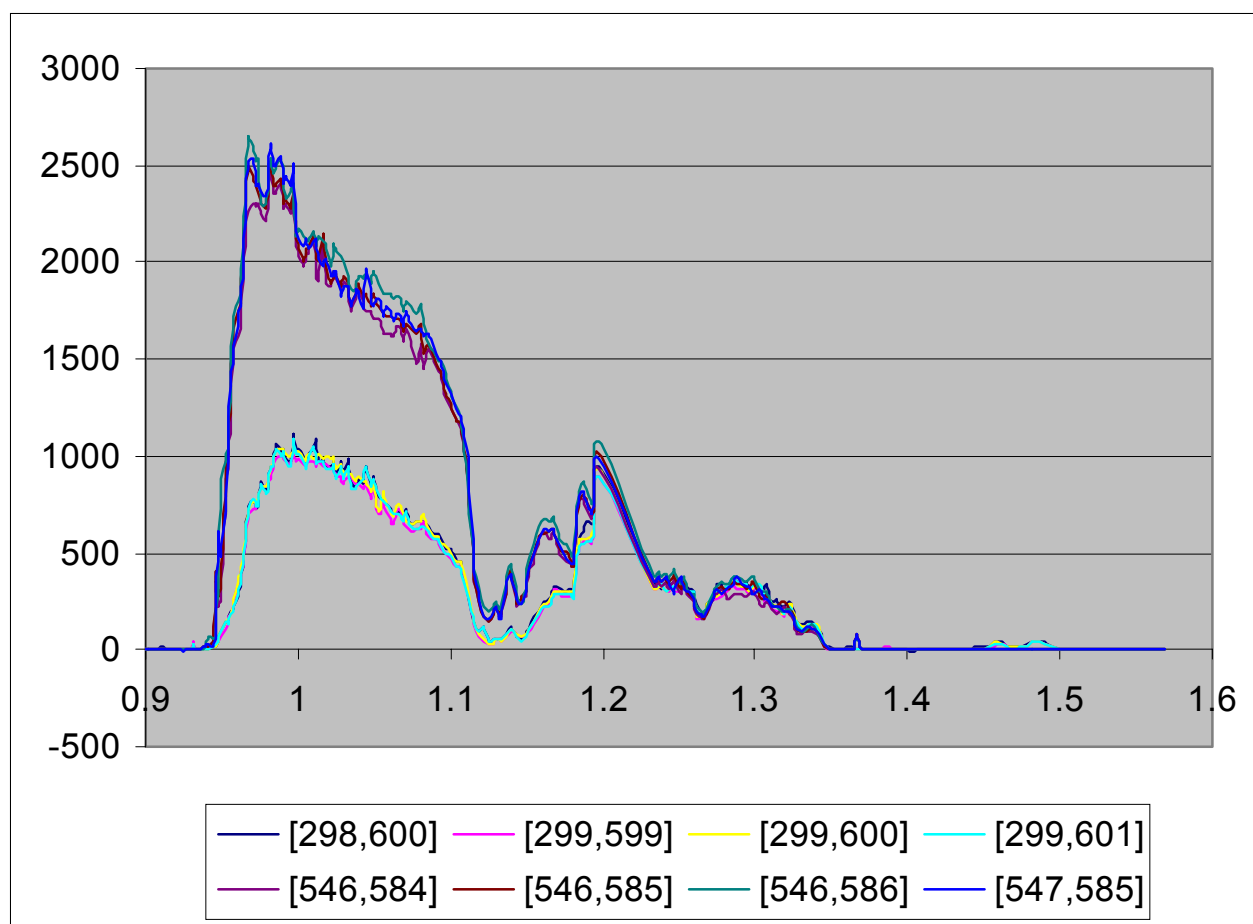
Spectra

Cuprite, NV

March 1, 2001

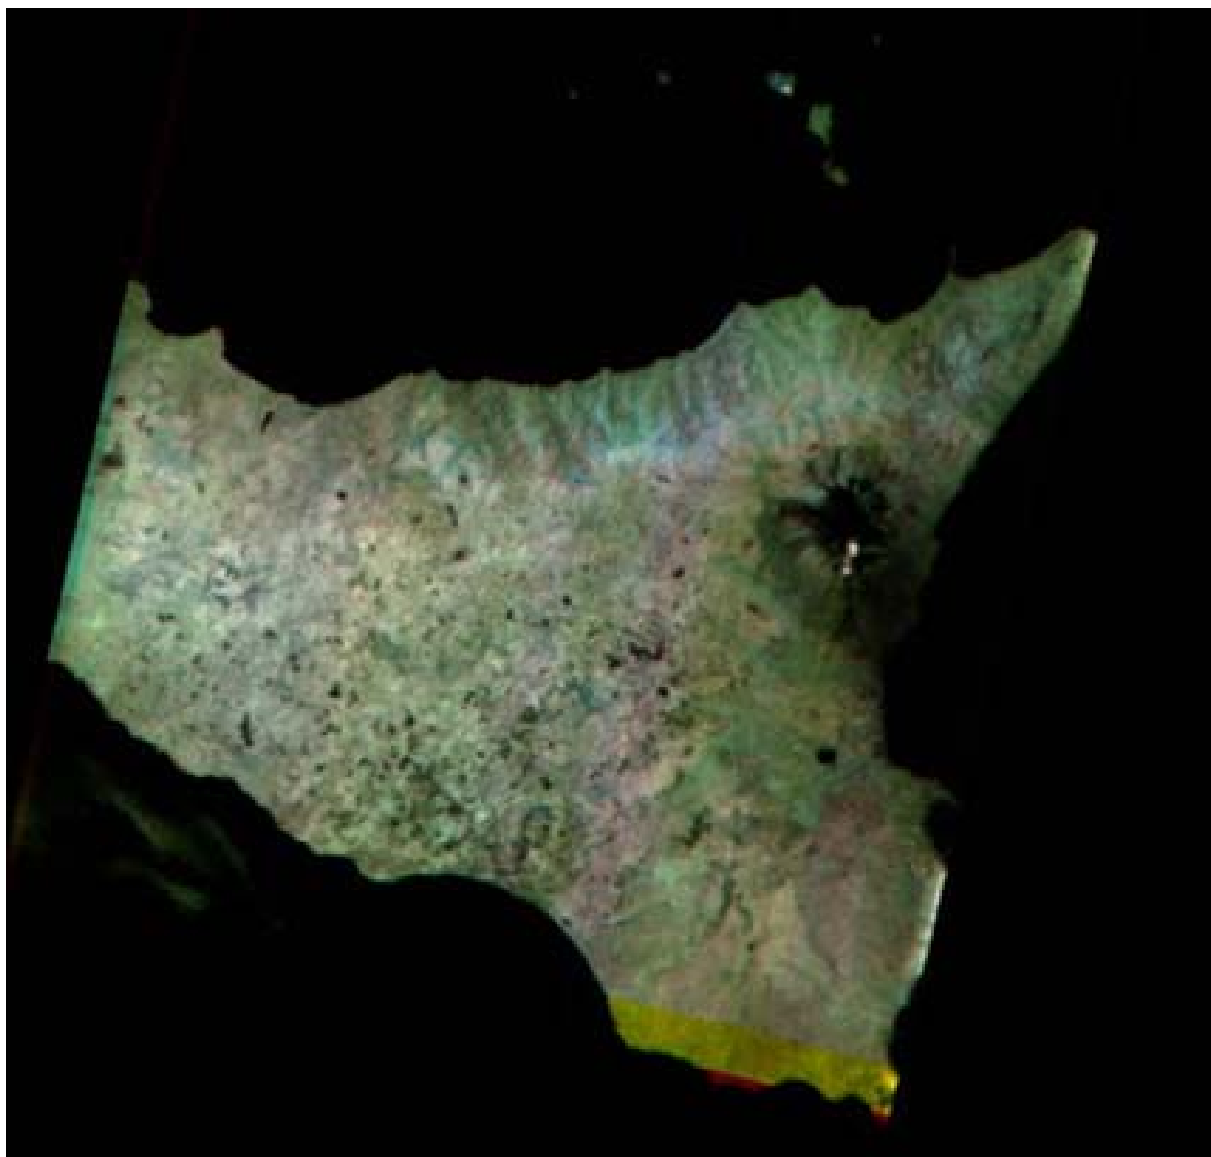
Mt. Etna 07/29

- ◆ *Red 1.275 μm*
- ◆ *Blue 0.988 μm*
- ◆ *Green 1.083 μm*

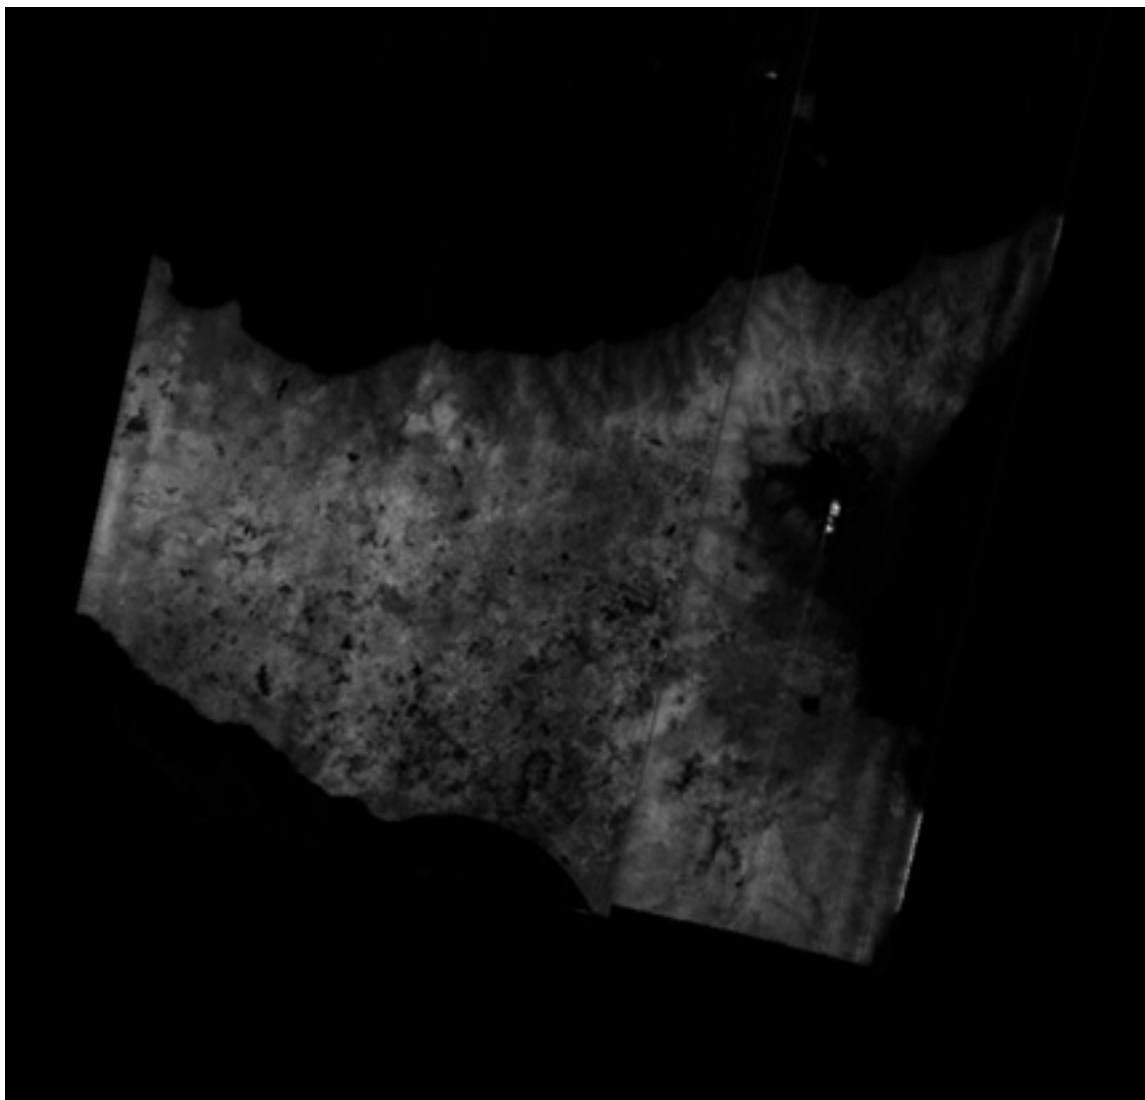
Mt. Etna 07/29

◆ *0.988 μm*

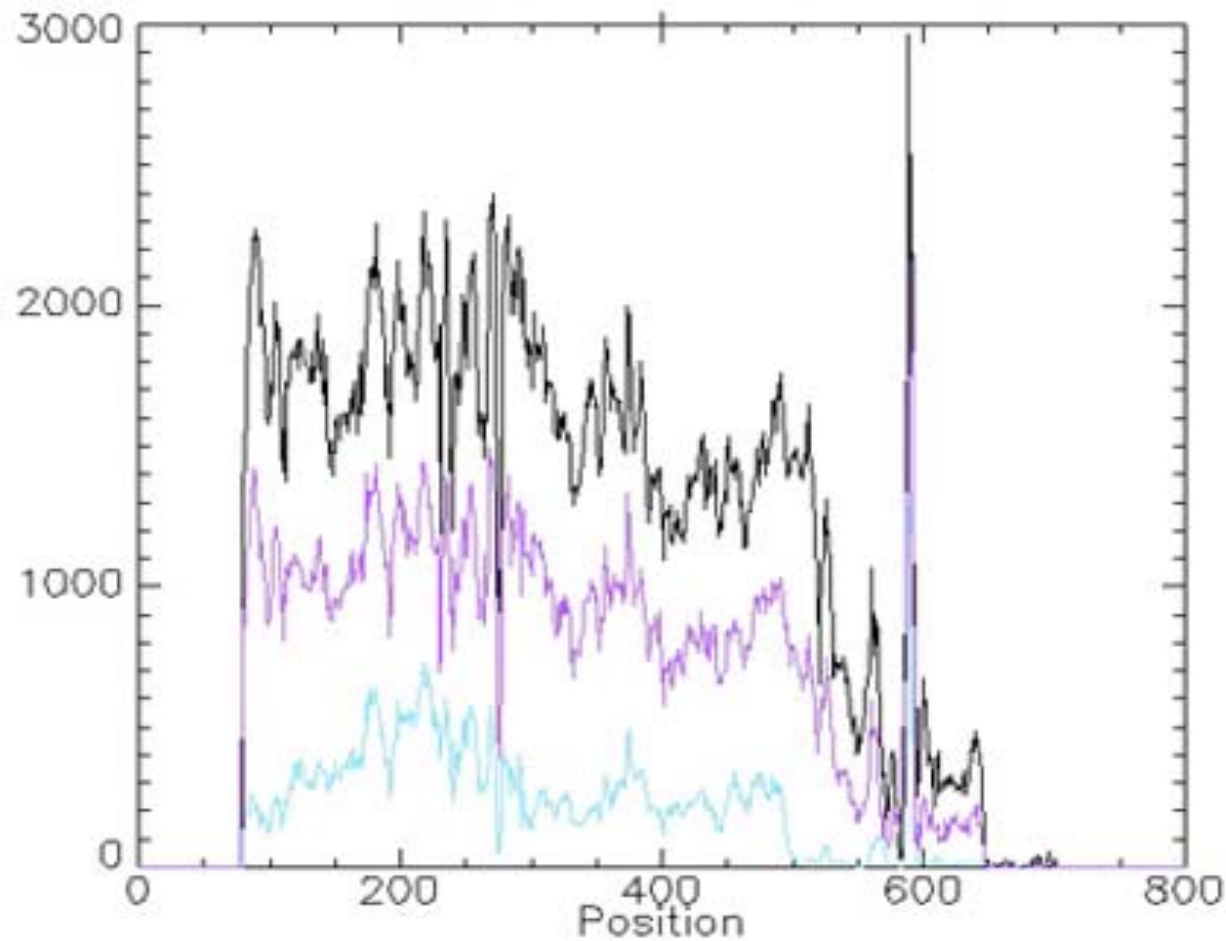
Mt. Etna 07/29

- ◆ **Black 1.005 μm**
- ◆ **Purple 1.080 μm**
- ◆ **Blue 1.097 μm**
